# EARTHQUAKE PERFORMANCE OF GABION WALL PORT VILA, VANUATU

## RETAINING WALLS

**Product:** Galmac/PVC Gabions, Bidim, Enkamat, Megaflo

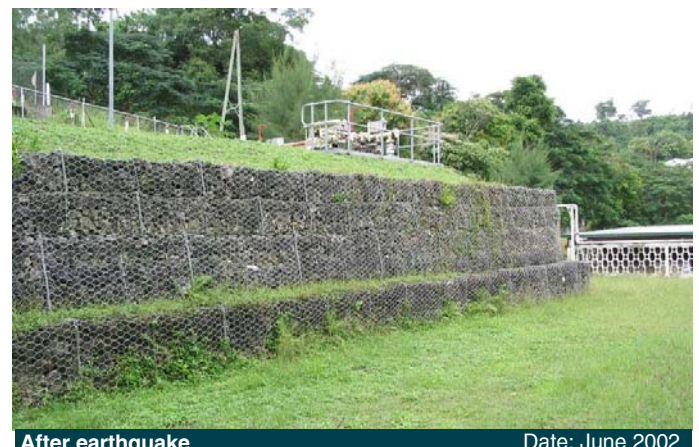
After earthquake

A visual inspection of the gabion wall showed no signs of distress to the structure and no tension cracks were observed in the uphill slope above the wall.

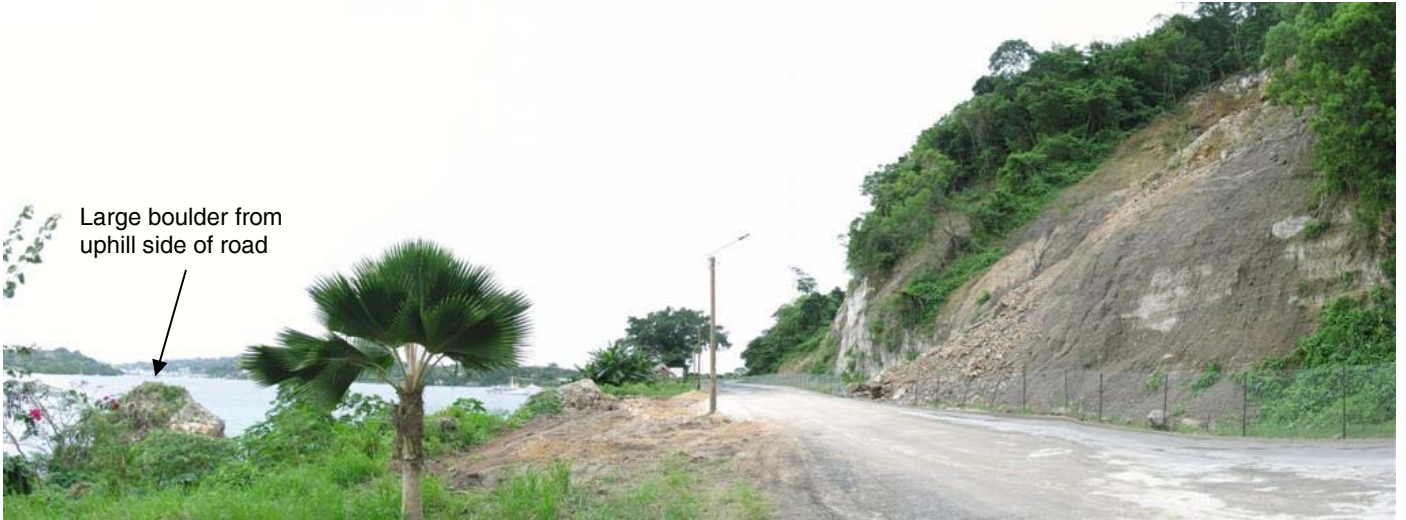
Landslip along Wharf road

The Boral Gas site is located along Wharf Rd, the site of two large landslides which occurred immediately following the main earthquake event. The earthquake caused significant blocks of limestone to break away from the cliff. In addition numerous fissures formed in the fill supporting the roadway.

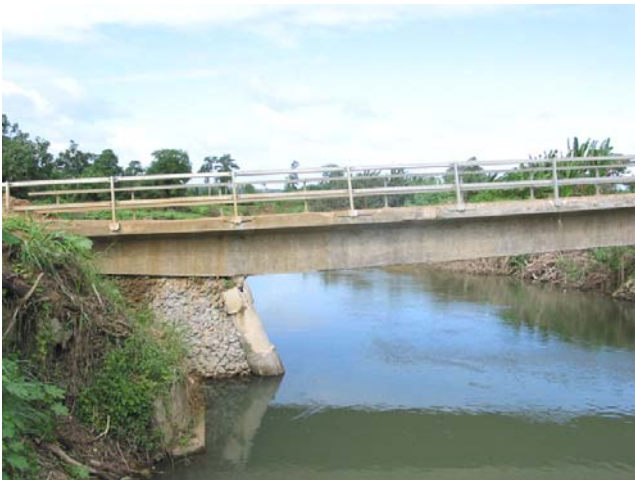
At another site the pier for the Tuama bridge on the road out to White Sands had failed and the bridge was being support by the gabion abutment which was grouted after the earthquake for additional security until such time as a new bridge could be constructed.

Collapsed bridge pier

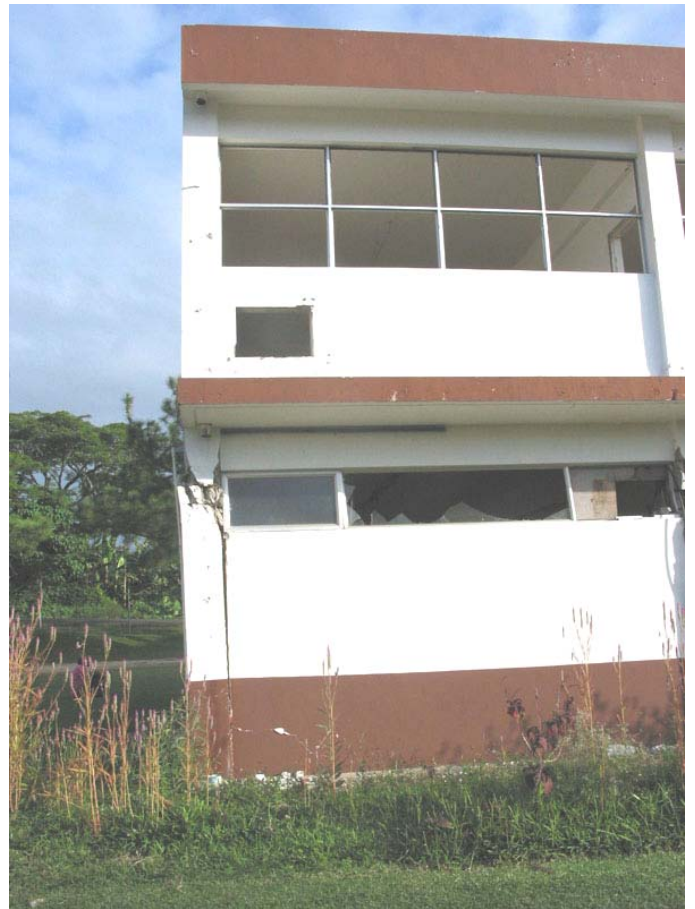
Column damage to school
