KAWAKAWA BAY LANDSLIDE MANUKAU CITY

RETAINING AND REINFORCED SOIL SYSTEMS

Product: Miragrid GX, Biomac Grasstrike, Bidim Geotextile

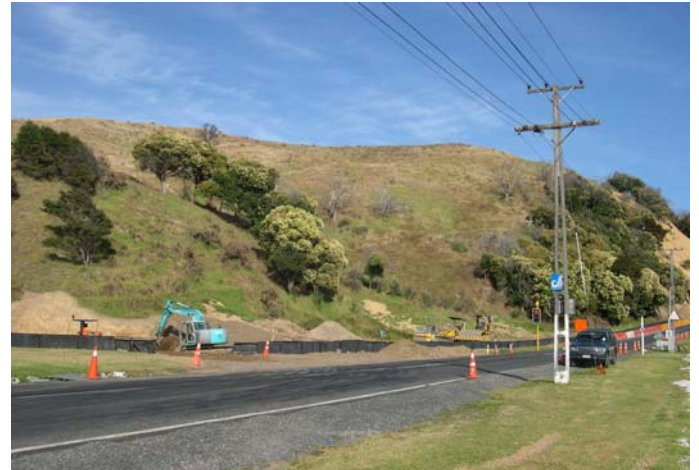
The initial site before construction

In July 2008, high intensity rainfall events triggered landslips across the North Island. One such slip occurred at Kawakawa Bay in early August 2008. Initially approximately 500m³ of slip debris fell from the top of a cliff face and blocked the Clevedon to Kawakawa Bay Road, with the debris sliding over and exposing the underlying local greywacke base rock.

Tension cracks and a head scarp feature were identified enveloping a house platform 100m back from the cliff face and it very quickly became apparent that a major deep landslide was affecting the whole of the hillside and cliff face. Daily survey of surface monitoring points confirmed that the landslide was active in the then prevailing wet weather conditions with accelerating movement of the order of up to 30mm per day (total displacements of the order of 500mm). Assessments of the potential run-out distances from the very large mass of the landslide (estimated at 400,000m³) indicated that at least five occupied dwellings at the foot of the hillside were potentially at risk of inundation with debris.

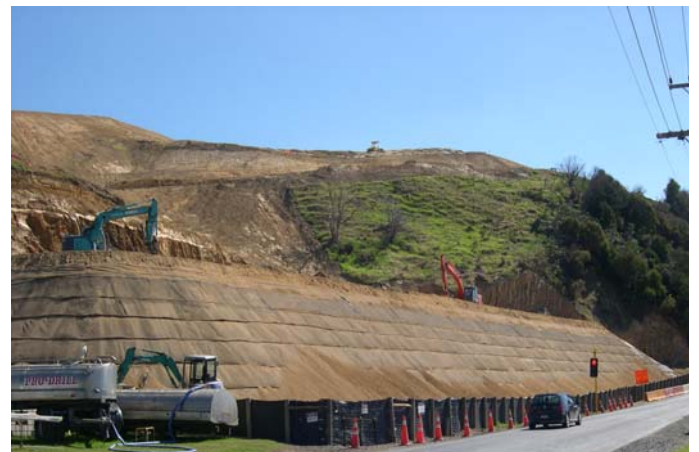
Building of the reinforced soil slope

Speed of construction was paramount to stabilise the hill side and stop a further landslide. The Miragrid geogrids met the design requirements and were readily available for the start of construction in late January 2009. With the wide roll widths at 5.2m this enabled the contractor to save time and money with a decrease in installation time. By utilising the biodegradable Biomac Grasstrike in the front face of the wrap around buttress structure a green finish was achieved restoring the hill (as close as possible to its original state).

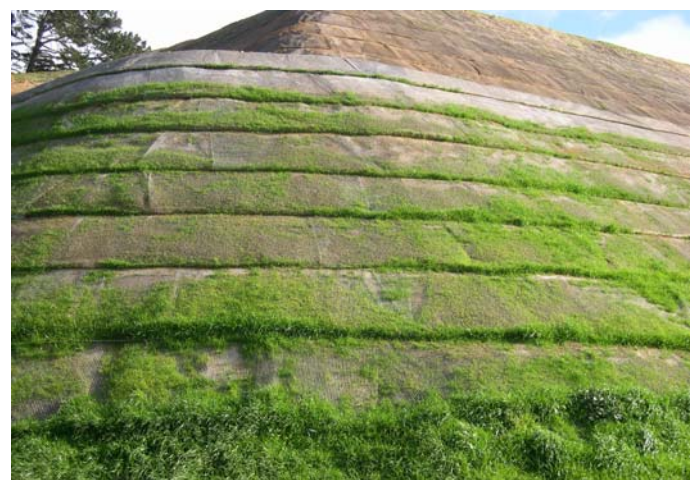
Greening of the reinforced soil slope

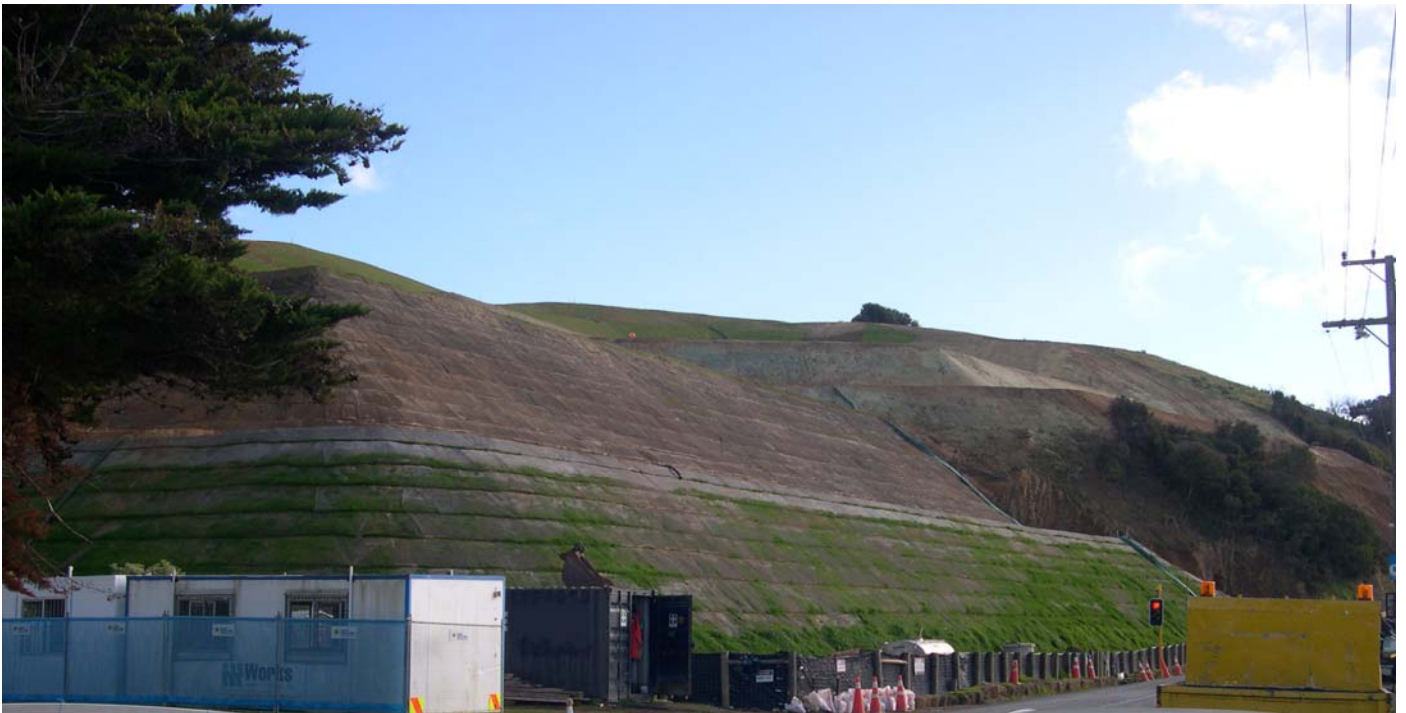
Completed Miragrid & Grasstrike reinforced steep soil slope
