HAMILTON GOLF CLUB ST ANDREWS, HAMILTON

BUNKERMAT STABILISATION

Product: BunkerMat

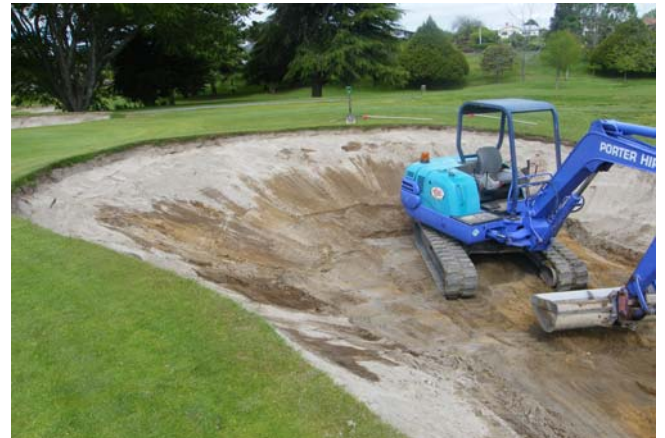
Preparing the bunker

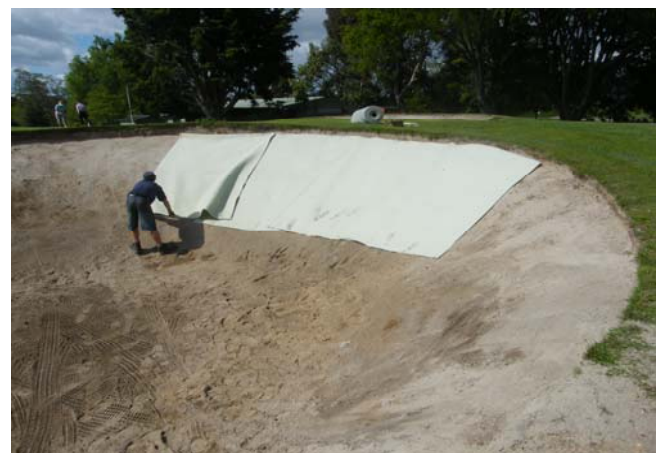
Installing BunkerMat

BunkerMat traps the sand within its fibres preventing sand movement through the mat profile. The dense 3 dimensional high UV resistant fibres making up the mat structure, also allows high in-plane water flow, which limits slip failures at the interface between the sub grade and high quality bunker sand. Bunker walls then require less sand but still gives the wall a deep sand appearance.

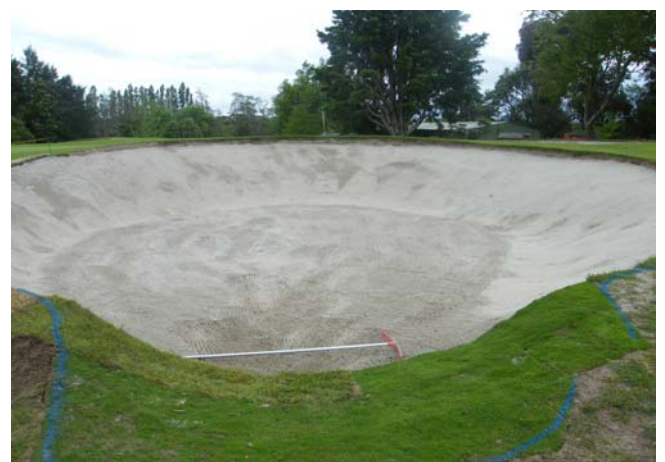
Completed 5th hole bunker

Gavin Cornish - Superintendent Hamilton Golf Club comments, "the **BunkerMat** is performing well and I am very happy with the results. We have experienced no washouts since the **BunkerMat** was installed. It also keeps weeds down and less maintenance is required. With 58 bunkers on the course, this is certainly a plus."
