ROCKFALL PROTECTION

Products: PVC Coated Rockfall Netting

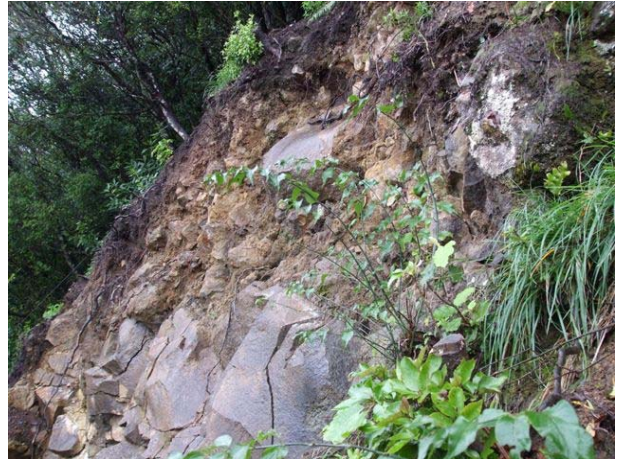
Eroding slope face prior to rockfall netting

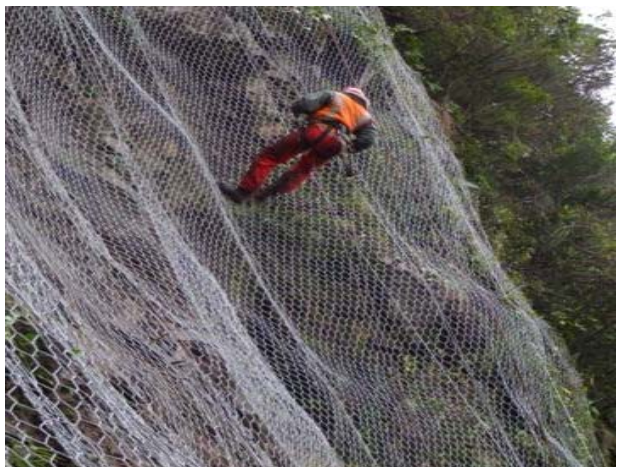
Avalon staff abseiling down the slope to place anchors

Maccaferri suggested a passive measure using a drapery system consisting of Maccaferri Woven Double Twist Rockfall Netting to cover up the entire slope face. Anchors were installed at the crest of the slope with steel ropes to support the load of the netting and any debris load.

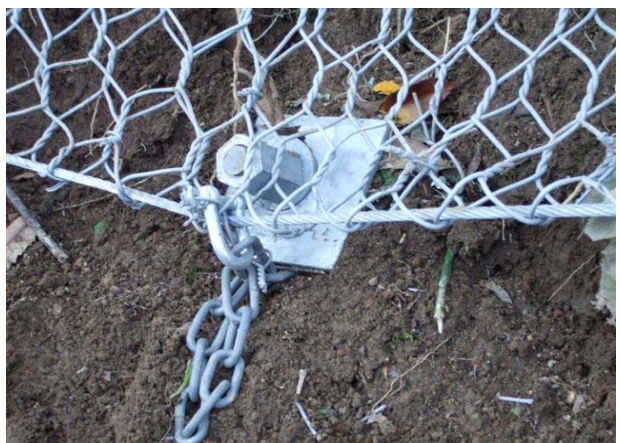
Anchor at the toe of the slope

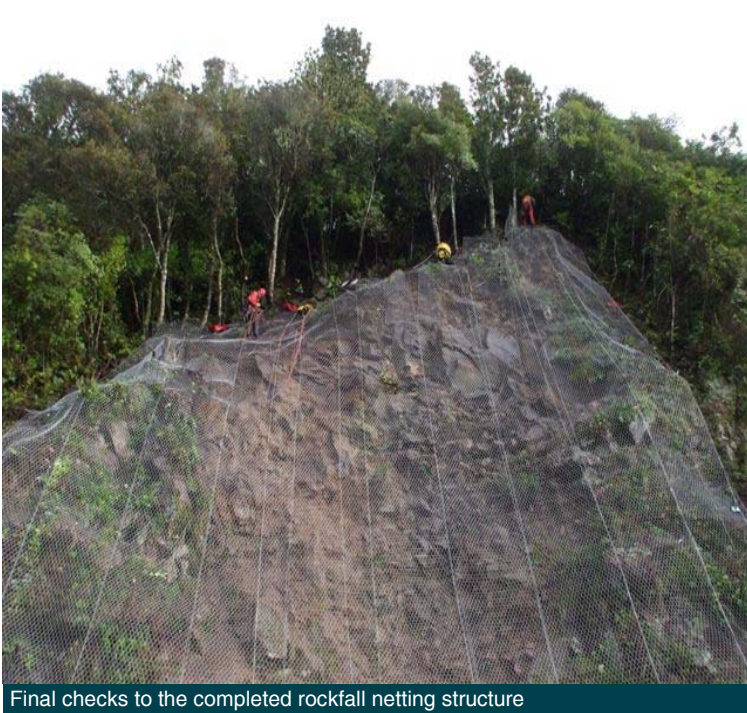
Final checks to the completed rockfall netting structure

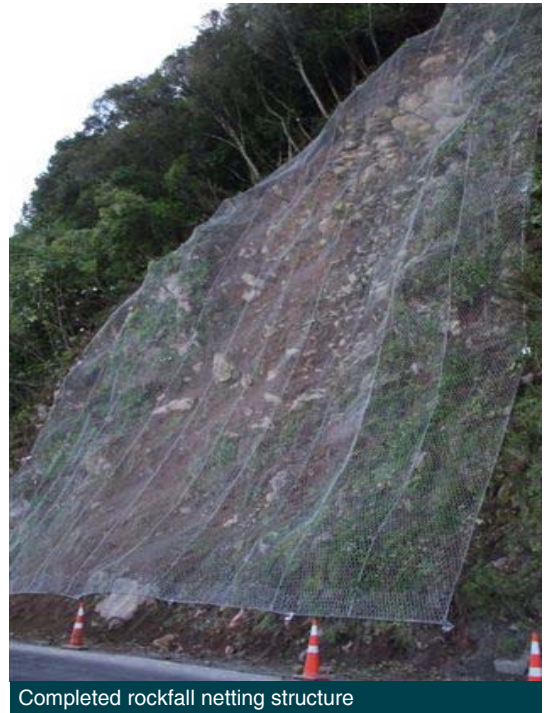
Completed rockfall netting structure
